# Navajo Abandoned Uranium Mine

# **Site Screen Report**

# Julius Chee No. 4 AUM Site

January 2011

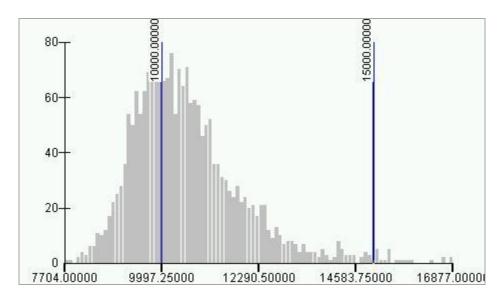
A total of 2,063 gamma radiation measurements were collected from the mine site, ranging from 7,704 cpm to 16,877 cpm. The measurements are represented in Figures 1 and 2.

The following chart and statistics were generated by ESRI ArcGIS 9.3.1, and show the general distribution of the site gamma radiation measurements. The horizontal X axis represents the gamma radiation reading levels in cpm (lowest levels to the left). The vertical Y axis represents the frequency of each gamma radiation level.

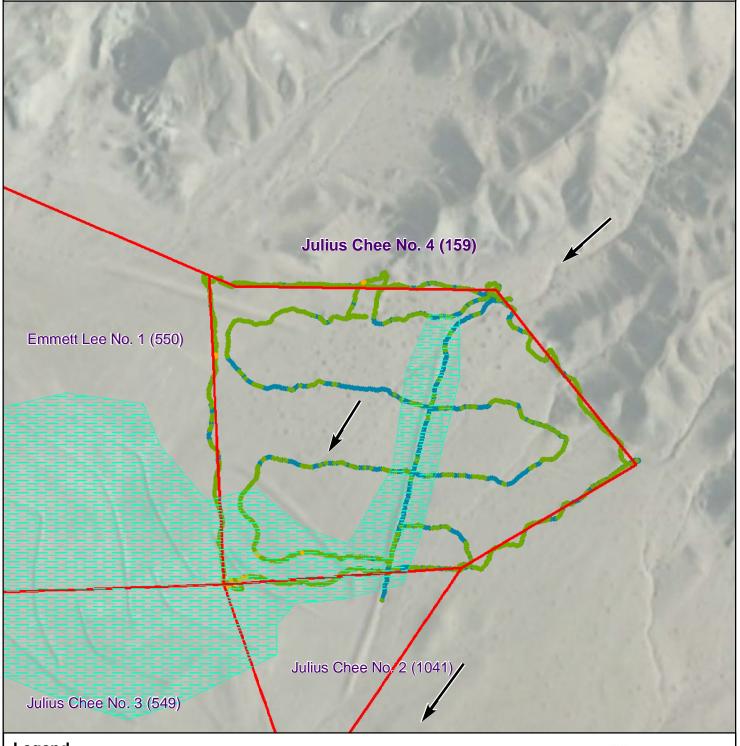
Average background 9,641 cpm
